RESTORATION PROFILE

A LONG TIME WITH A LLOYD

1958 LLOYD Alexander

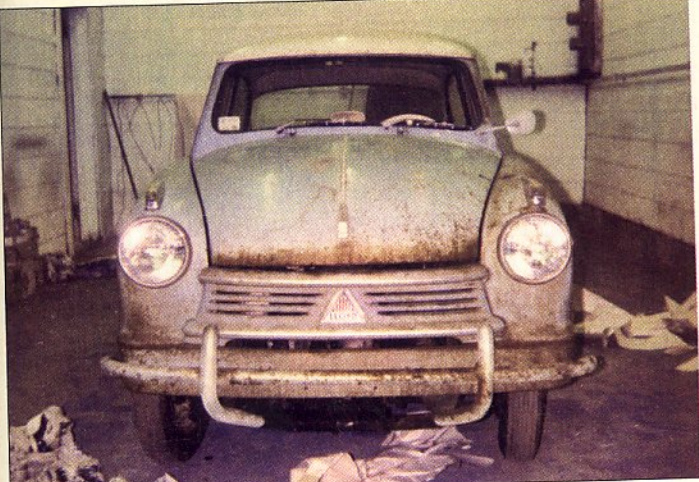
As it arrived in Steve Rice's body shop, the Lloyd was suffering from the kind of surface rust you might expect from 28 years of storage in a dirt-floor garage. Here's the best news: Not one piece was missing.

More good news: There was not a single spot where the sheetmetal had rusted through, and the only accident damage was one small dent in a front fender. Even the factory blue and white paintwork had survived.

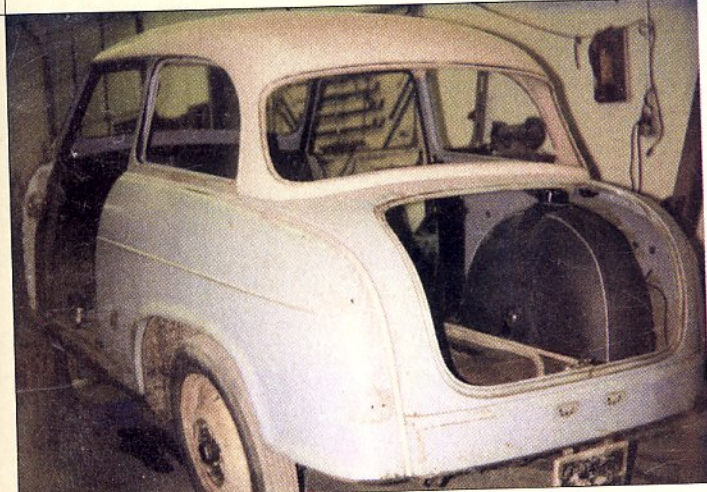
With the car supported on jackstands, disassembly was straightforward. Removing the windows without damaging the gaskets or cracking the glass required the use of dish soap as a lubricant, and gentle pressure.

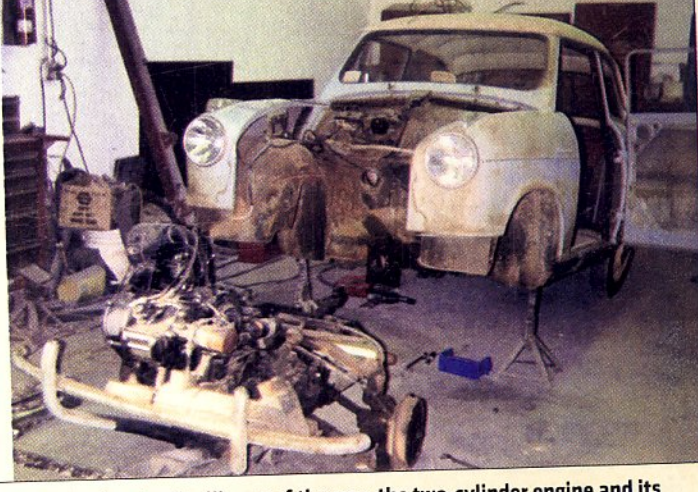
With the hood and grille out of the way, the two-cylinder engine and its attached gearbox could be dropped out. The whole assembly attaches to the tubular backbone of the car with four large bolts.

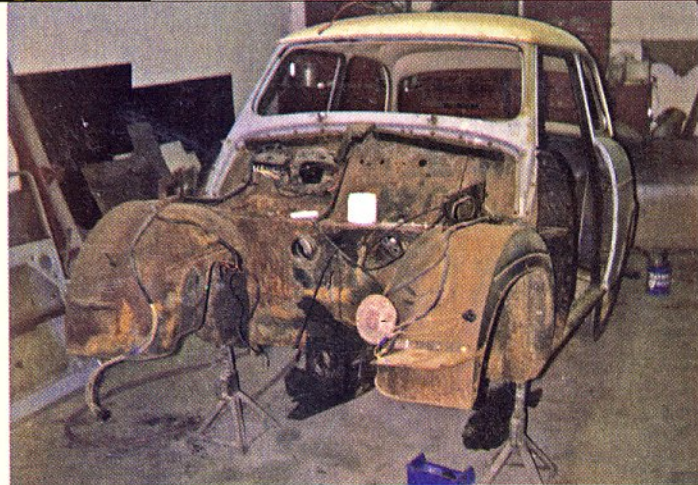
It looks nasty, but this is merely surface rust. After fully disassembling the body shell, Steve stripped everything back to bare metal, either by sandblasting or the use of an abrasive disc on an air sander.

After tearing down the rest of the car, Steve said he sandblasted the entire body, inside and out, with either silica sand or Black Beauty blasting media. "This was also before walnut shells or plastic media," he said. "And if I used any chemical stripper, it was minimal, compared to the blasting."

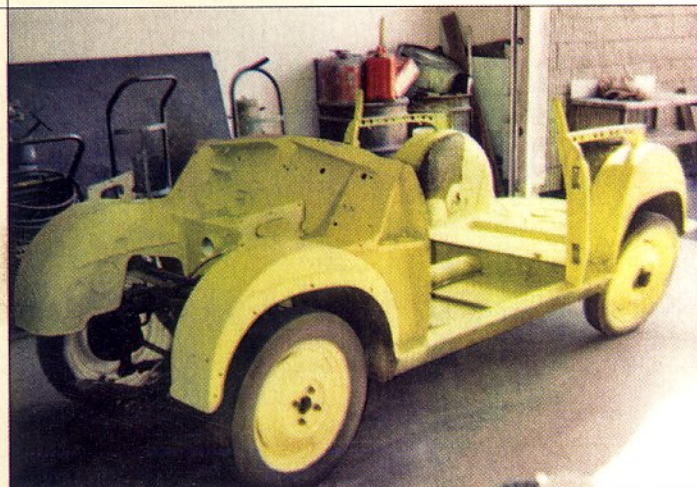
The chassis was sprayed with Sikkens single-stage urethane primer. Note that the B-pillars, which carry the weight of the rear-hinged doors, and their horizontal supports remain welded in place.

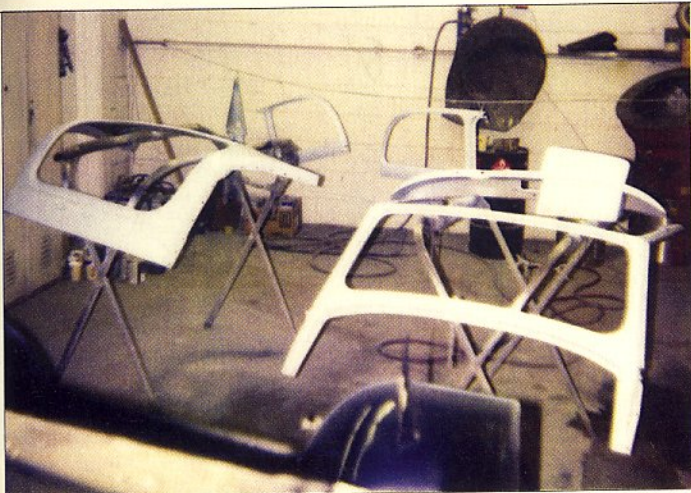
All body panels were stripped, primed and painted off the car, again using Sikkens products. Although the shop has a spray booth, Steve painted some of the parts in his workspace, after wetting down the floor.

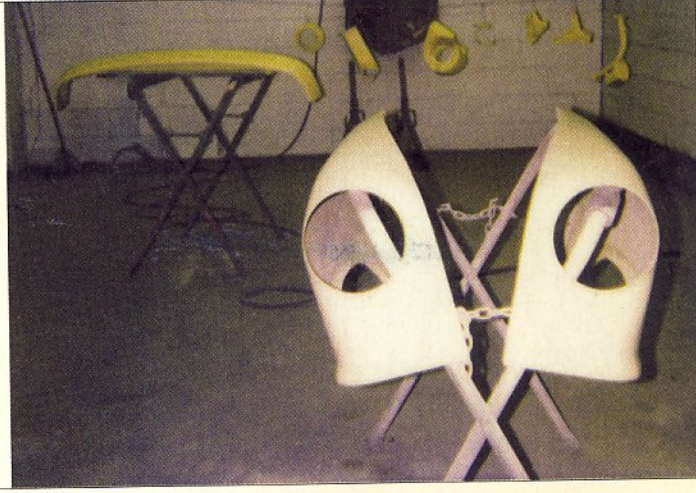
About a teaspoon's worth of filler, to fill in a dent in a front fender, was all that the car needed. A paint supplier matched the original colors, using areas of the car that had been protected from fading.

Steve found that he needed to use very little filler on the Lloyd, recalling just one dent in the fender that needed to be straightened. With that taken care of, he then sanded the bare metal to rough it up for the several coats of primer he sprayed, then sanded smooth. On top of that, he sprayed three

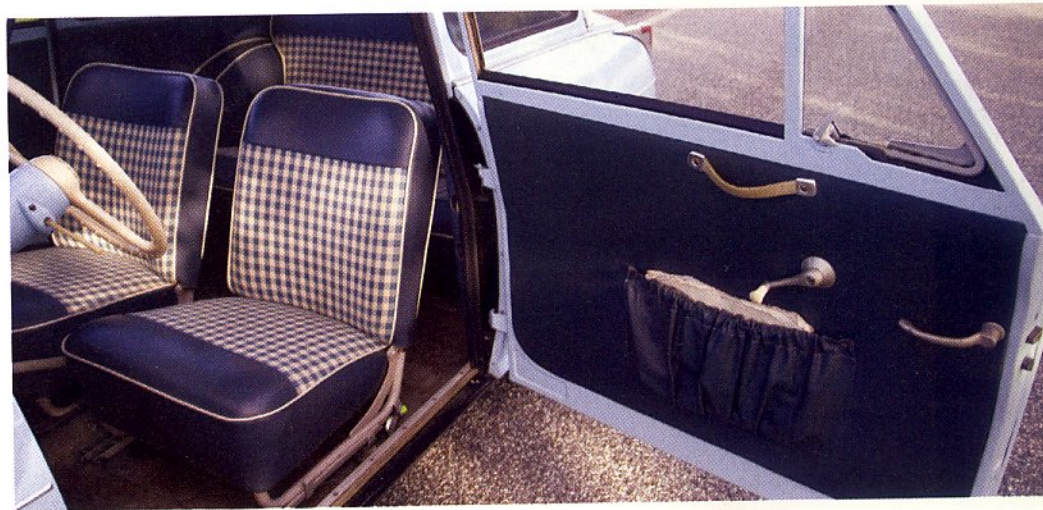
With the passage of time, Steve can no longer recollect who rechromed the bumpers, door handles, mirrors and hubcaps. Same goes for the upholstery shop that Steve hired to reupholster the seats after he stripped them of their rodent-nibbled covers, then sandblasted and painted the frames. "I do recall that we felt there was no way to recover the seats in NOS or reproduction seat fabric," Steve said. "So

we went with material that was as close as we could find to the original."

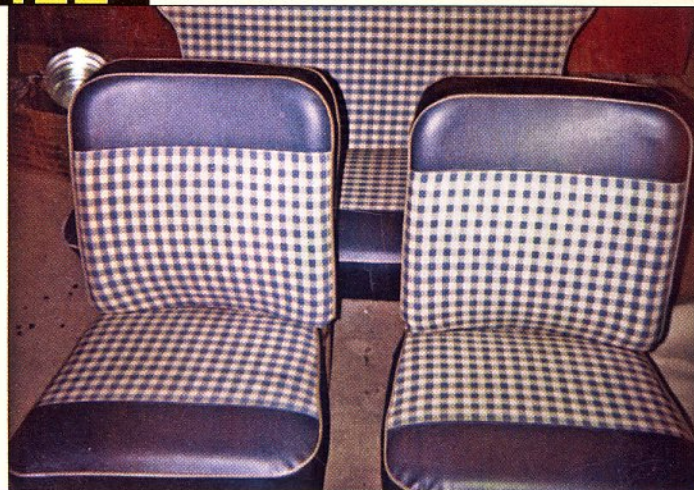
With the old upholstery and eau-de-rodent padding removed, the frames were cleaned and painted, and brought to a local shop for new coverings. The checked cloth was the closest match for the original pattern.

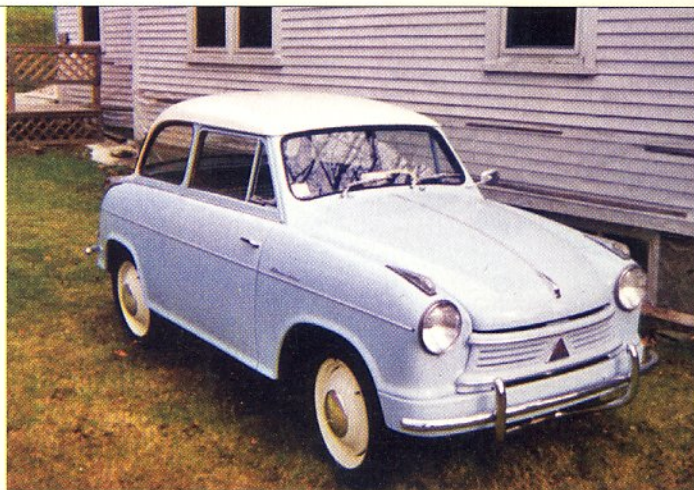
Its fresh chrome and polished stainless trim sparkling, the Lloyd made the trip back to Harold's house in Vermont on Steve's trailer.
